Daily Report For 2016-05-12

Metal Bank

Sheetpile Repair
Cottman Avenue
Philadelphia, PA (US)
Report number: 3340011G-5
Date: May 12, 2016 11:16 AM

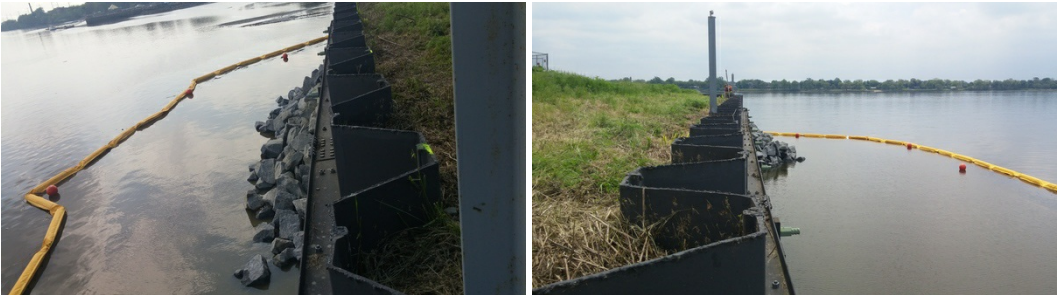
Remark	Description
Rip-Rap	
✓ R6 Stone Placement [3.1] May 12, 2016	(see pics below)

Stone berm installation progress in the area between Target E and Target D (photo taken from Target D looking towards Target and Target F (facing east E))

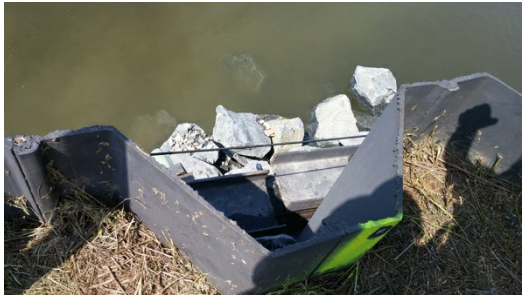
Stone berm installation in the vicinity of Target E.
